Flexural behaviour of BFRP rebar reinforced concrete beams

The Plymouth Student Scientist

Project Advisor: [Dave Easterbrook](#), Plymouth University, Drake Circus, Plymouth, PL4 8AA

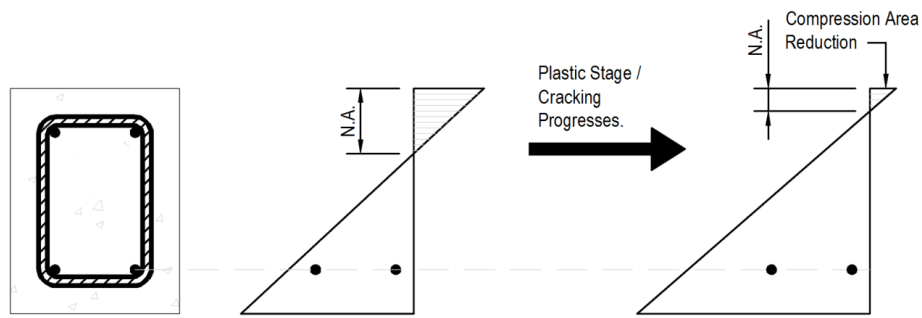
Beam bending tests showed that the concrete beam (B1) reinforced with 100% traditional steel reinforcement (refer to Figure 4), experienced compression failure as illustrated in Photo 6. This can be explained by the fact that once the concrete beam cracks, the neutral axis shifts higher towards the top of the concrete beam section. As this progresses further, the top area withstanding compression generated by the external load, reduces until the concrete’s compressive strength becomes lower than compressive force generated on to the beam by application of an external load. This causes concrete to spall from the top of the concrete beam and the beam to fail. Figure 6 depicts the compression area reduction in reinforced concrete beam. Furthermore, the compression failure (refer to Photo 6) occurred prior to steel bottom tension bar “snapping”. (refer to Photo 7).

Figure 6: Neutral Axis Shifts Up as Cracking Progresses.

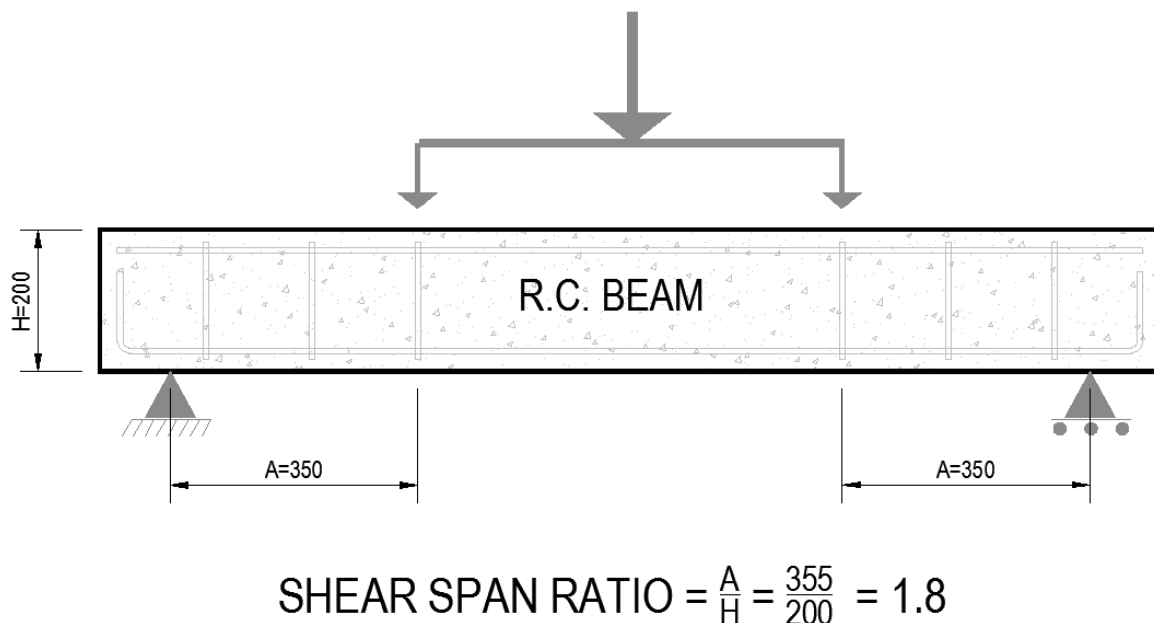
Ultimately, it is important to note that shear failure in BFRP rebar reinforced concrete beams occurred at one end only (refer to **Photo 6**). This could be caused by marginally different reinforcement position at each end of the beam. It is possible that reinforcement could have dislocated from its original position during the beam casting stage when a vibrating poker was used. In addition, that marginal difference in shear link spacing, during the reinforcement cage assembly phase could have contributed to the unsymmetrical reinforcement setup. Furthermore, the analysis carried out suggests, that the shear span of the tested beams was 1.8, as depicted in Figure 7. This suggests that the shear span ration was too low and potentially resulted in shear failure BFRP rebar reinforced beams as illustrated in Photo 6. Naik & Kute (2014) suggested that, that to prevent shear failure, shear span to depth ratio should be greater than 2.5.

Figure 7: Shear Span Ratio of the Reinforced Concrete Beams.

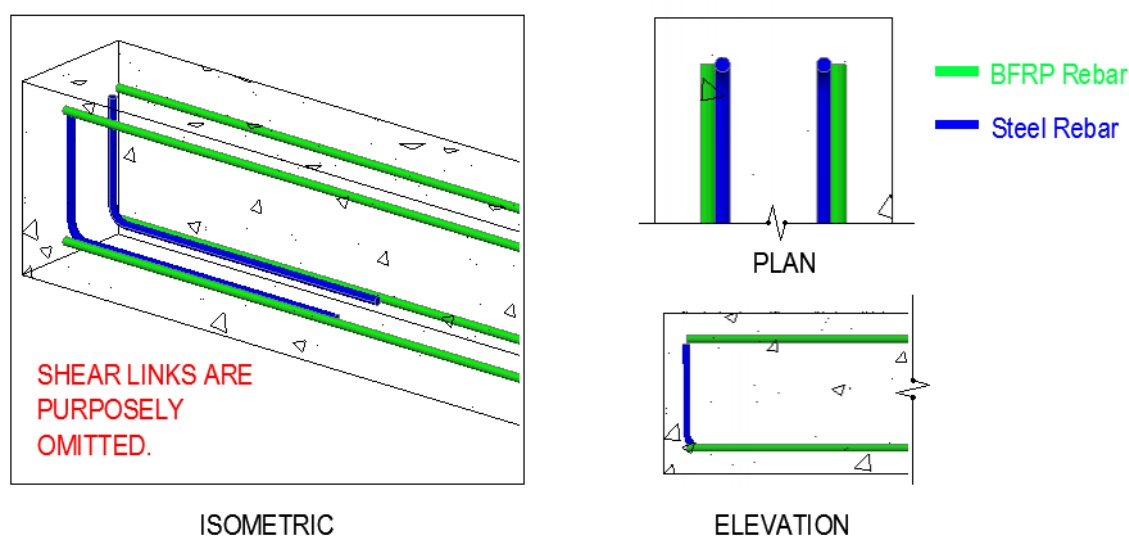
To avoid the failure of BFRP rebar described in section 6.4.4, further improvement could be made by placing steel L bars to the side of the BFRP longitudinal tensions bars (refer to Figure 8).

Figure 8: Steel L-Bar Location.
